OBJECTIVE: To demonstrate the use of Goldseal Anticorrosive Coating in combination with other surface coatings on a wharf in Western Australia.

BACKGROUND: In 2009 Coogee Wharf near Fremantle was put out for maintenance tender. This involved the repair of Galvanized handrails, bolt replacement, sand blasting and painting of steel box members. Below the splash zone required pile cleaning, Denso wrap system and Anodes.

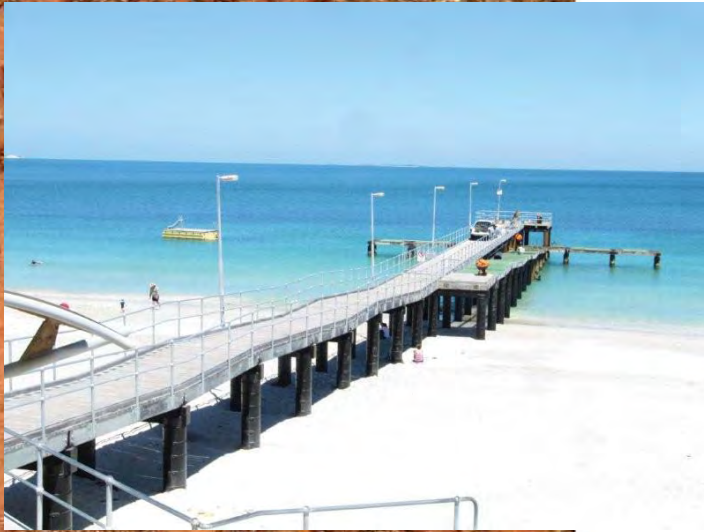
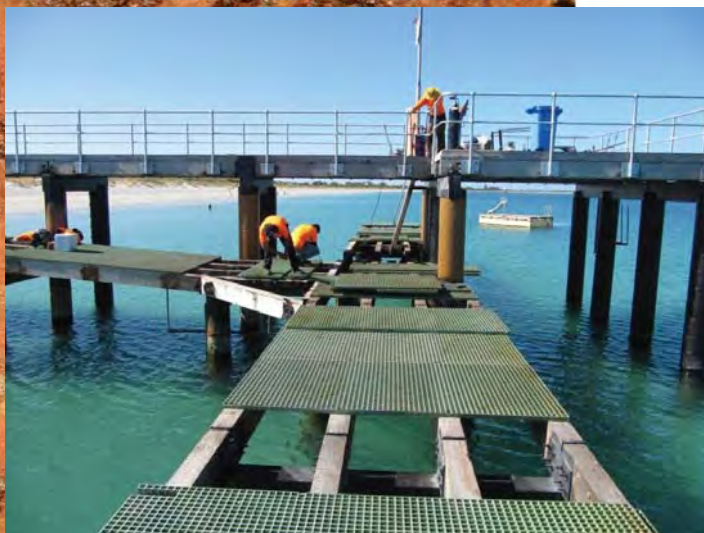
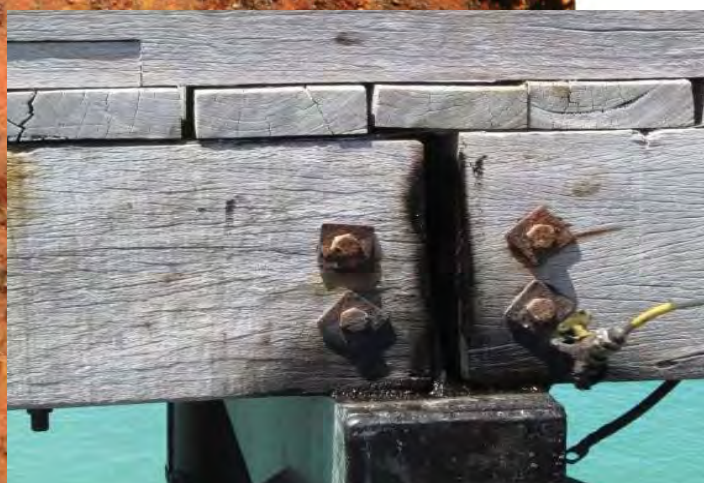
- a. Advanced Eco Blasting used their environmentally friendly cleaning process to prepare the steel and spray applied Interzone 954, a single pack marine coating.
- b. The wharf deck bearers are slotted and fixed to the steel box cross members by bolting through a vertical steel plate. The use of Goldseal in these slots meant the wharf deck and bearers did not need removing. The slots were blasted and painted. Hot Goldseal was then applied airless into the slots. The liquid goldseal hardens immediately on contact, coating to 10,000 microns in one application.

c. The product remains mobile for 3 months and will penetrate and kill existing corrosion. Goldseal will capillary into cracks and behind washers producing a chemical and water resistant flexible seal that will not crack or peel
